# Manhole Inspection Summary

Manhole # S19Y\_\_005MH

Insp Date: **6/4/08 1:21 PM**

**Location** Address: **2413 harman av**

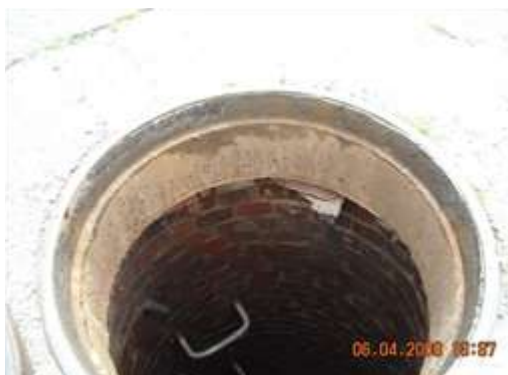
Defect 7

☒ **Leaks**

inflow evidence from sheeting (frame leaks)

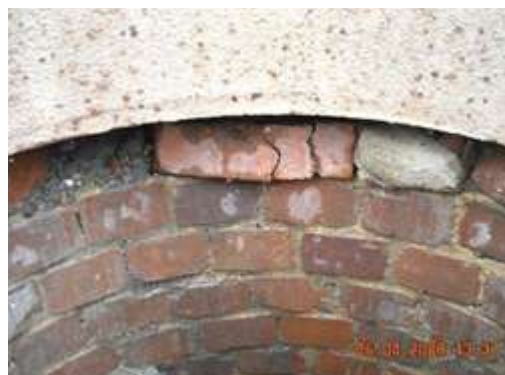
Defect 6

☒ **Cracked**

cracked chimney brick

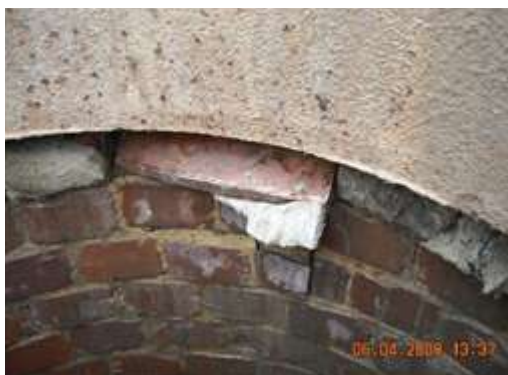
Defect 5

☒ **Loose Brick**

loose chimney brick

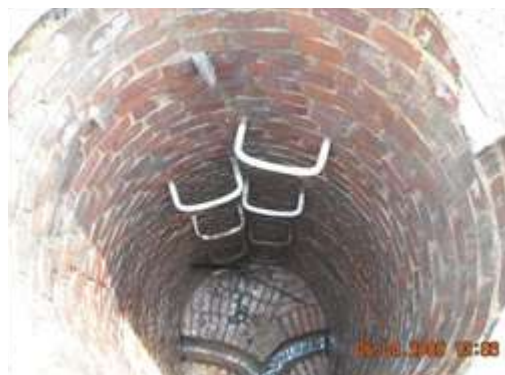
Defect 4

Missing: **1**

☒ **Corroded**

corroded & missing step

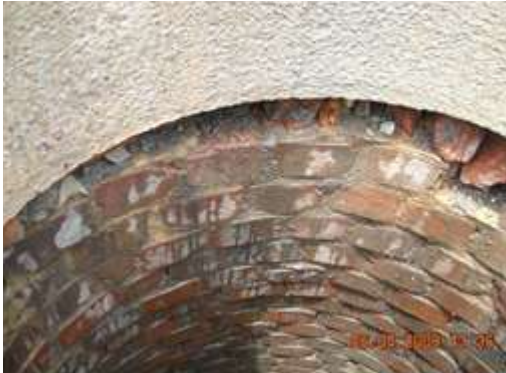
Defect 3

☒ **Joint**

infiltration @ chimney/frame joint

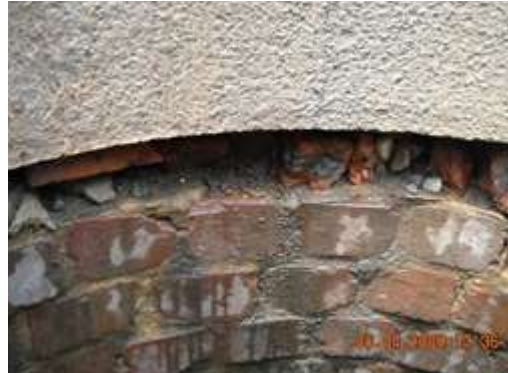
Defect 2

☒ **Deteriorated**

deteriorated chimney

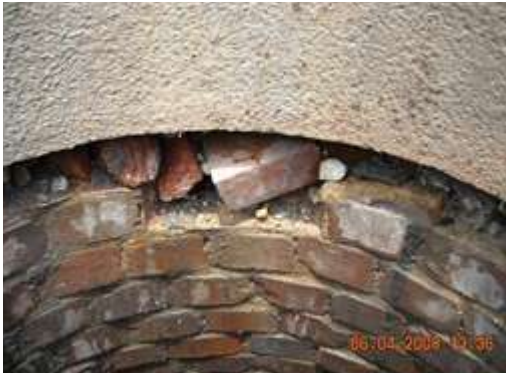
Defect 1

☒ **Loose Brick**

loose corbel brick

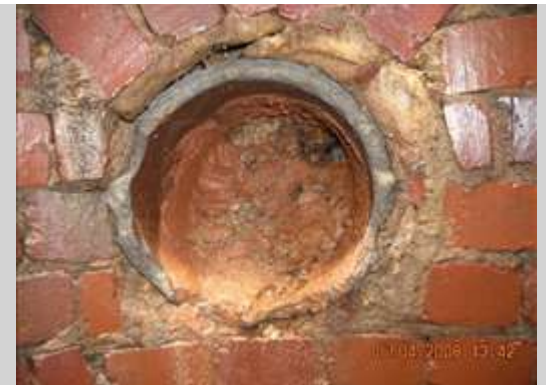
3 O'Clock Inflow

Pipe Height: **8.4** (in.) Rod and Bar (Angled)  
Pipe Material: **Clay** ☐ Pipe Lined  
Invert Depth: **7.14** (ft.) Flow Characteristics: **Slow**  
Deposits: ☐ None ☒ **Mud** ☐ Sludge ☐ Debris ☐ Grease  
Silt Depth: **7** (in.) Deposits Extent: **Heavy**  
Infiltration: **None** Pipe Seal Cond: **Sound**

Drop: **Outside** Rod and Bar  
Angled: **Yes** Reading: **13.04** (ft.)  
Inv Depth: **14.04** (ft.)

Drop Condition: **Partly Clogged**
